TECHNICAL REPORT

FIFTEENTH BIMONTHLY TECHNICAL PROGRESS REPORT A LUNAR SEISMOMETER CAPSULE SUBSYSTEM FOR RANGER

Under Contract: JPL Contract N-21453
(Issued Under NASA Contract NAS7-100)

Reporting Period: 19 August to 18 October 1962

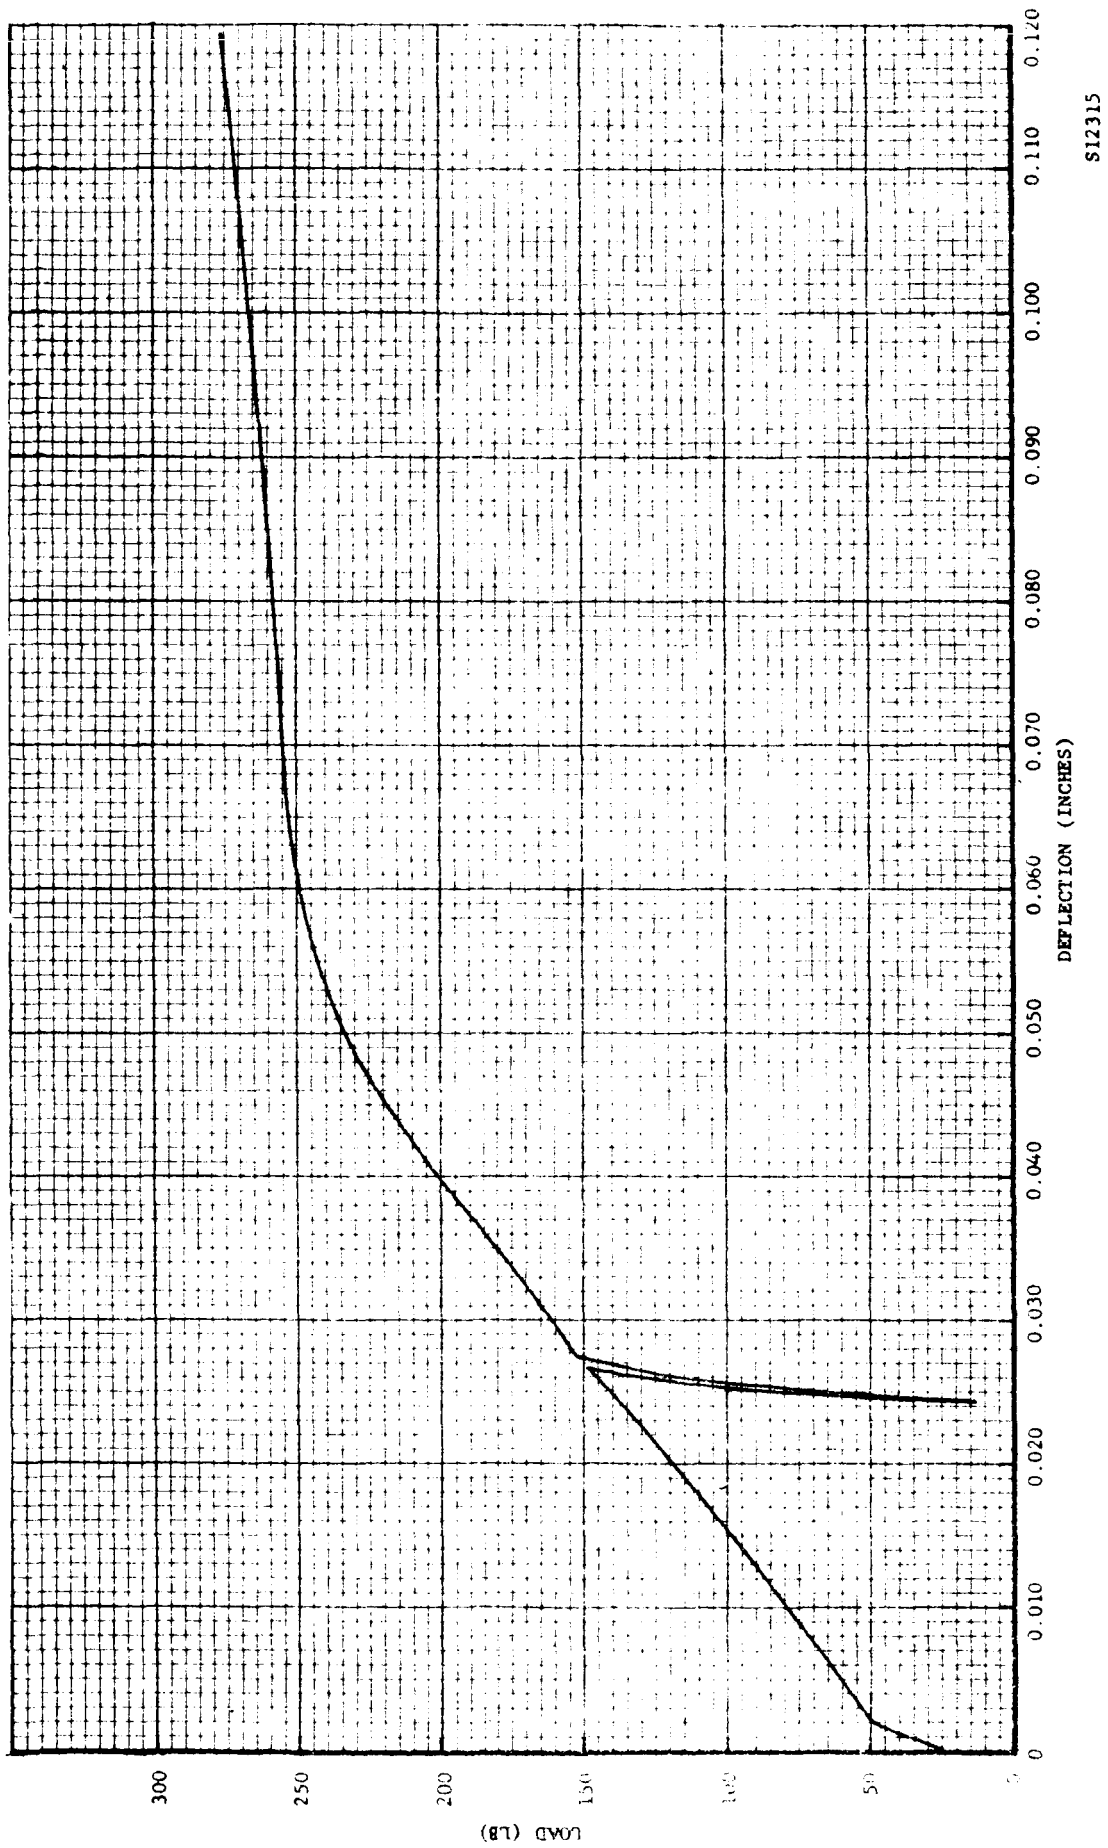
FIGURE 2. RETROMOTOR CLOSURE PLUG PULLOUT LOAD VERSUS DEFLECTION
(PRIOR TO INITIAL SEATING OF PLUG)

Pull tests were performed by Hercules Powder Company 16 November 1961, to obtain data for determining assembly techniques. These data are shown in Figure 2. As a result of these tests, it was decided to "seat" the plugs for flight motors by application of 150 pounds' force at assembly to reduce deflection under flight loads.

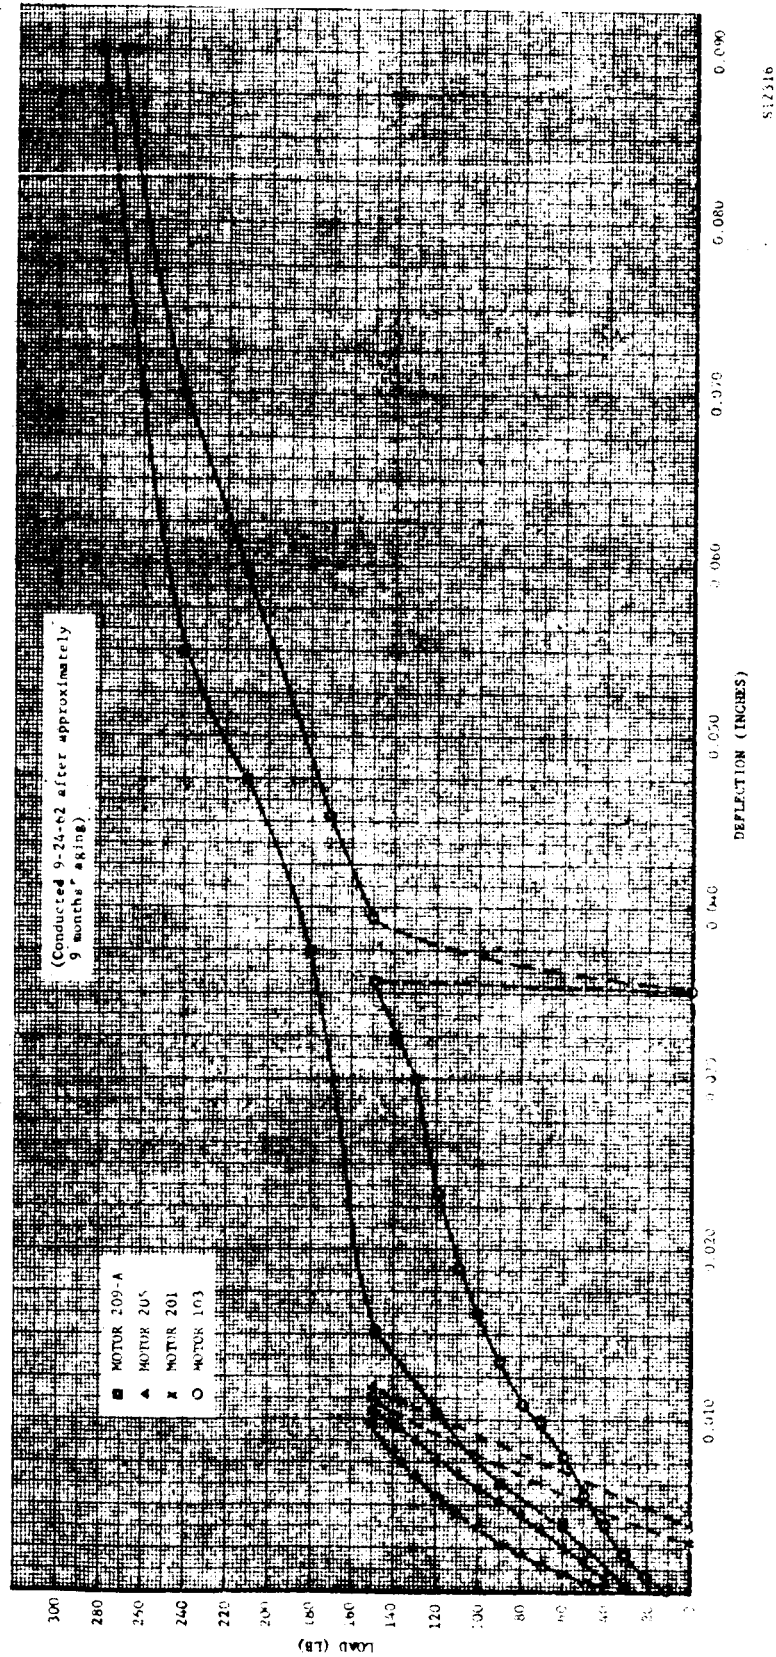
FIGURE 3. RETROMOTOR CLOSURE PLUG PULLOUT LOAD VERSUS DEFLECTION (SURVEILLANCE TESTS)

To verify that aging had not deteriorated the load-carrying capability of these plugs, pull tests were performed on the four test motors at AEDC. Results of these tests are shown in Figure 3. Motors 205 and 201 had been "seated" with 150 pounds' preload, while motors 209-A and 103 were assembled prior to that requirement.

Comparison of the two figures indicates no significant degradation had occurred. The plugs in the flight motors for RA-5 are considered satisfactory for use.

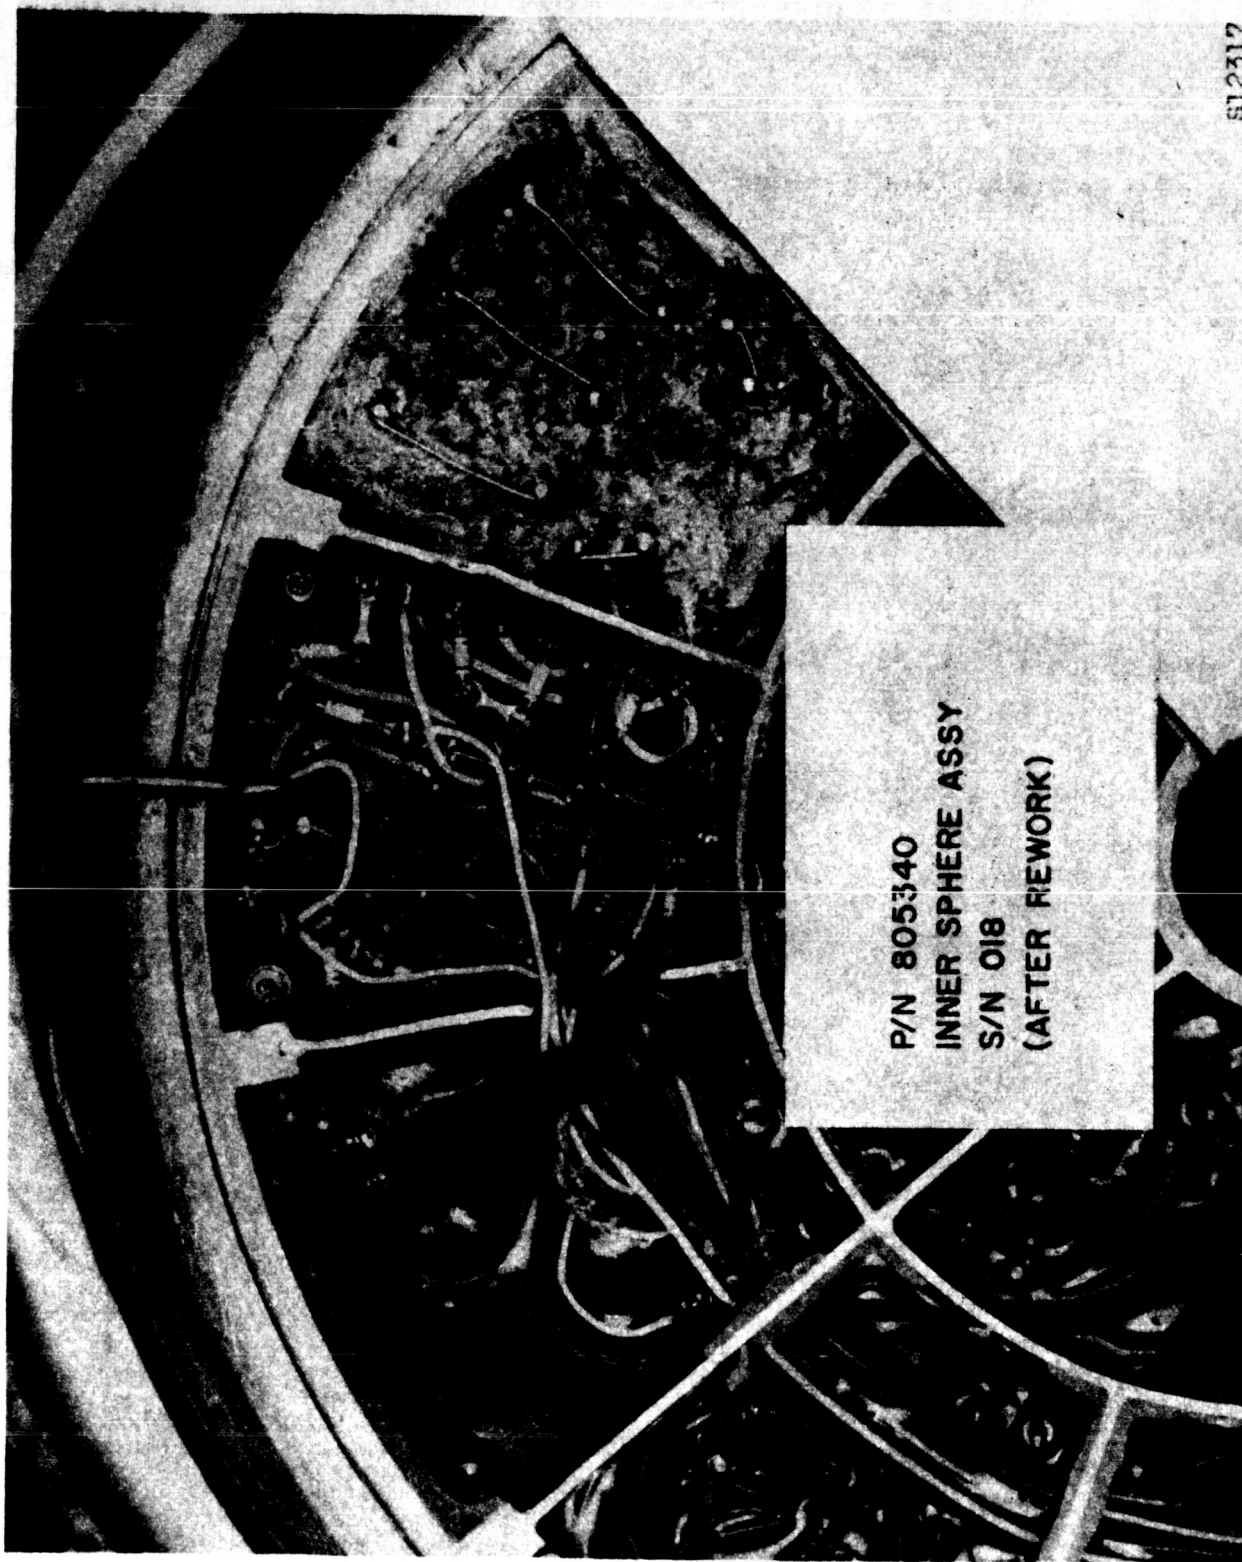
FIGURE 4. CAPSULE 018 INNER SPHERE ASSEMBLY (DURING REWORK)

The squib switch assembly is solidly encapsulated with 328 epoxy resin in one of the cavities in the upper structure. Although replacement of the squib switches appeared impossible, a technique for removing the encapsulating material was developed which allowed replacement of the entire module without detectable effect on the quality of the resulting assembly or functional reliability of the system. It was determined that the 328 resin softens at a temperature of about 180°F, which is well below the temperature at which insulation and other electronic components would be damaged. Heat was applied by a small hot-air gun, and temperature was monitored by a thermocouple in the air blast. As the encapsulating material softened, it was scraped away with a plastic stylus. By working very carefully, wire bundles that were freeze-coated over the squib module were freed, and connections unsoldered, and the defective module removed without significant damage to the surrounding components. After a squib module with unsterilized squibs was installed, each of the leads that had been disturbed rechecked both physically and electrically prior to reinstallation. The details of this inspection and any corrective action required are included in Tables 1 and 2.

A photograph of capsule 018 inner sphere assembly during rework is shown in Figure 4. At this stage the wiring is not freeze-coated and the battery terminals have not been re-encapsulated. All wires are the original ones, as can be noted by fragments of epoxy on the wires. Note that two of the wires have been sleeved because of minor nicks in the insulation that occurred during rework. The appearance of capsule 017 was similar.

As previously noted, it was discovered during test of the power and sequencing assembly that the Atlas squib switches would not function after sterilization baking. At the time this was discovered, spheres 017 and 018 had been partially assembled and incorporated and sterilized squib switches. Assembly had proceeded past the installation of the insulation shell of both spheres. It was therefore necessary to remove the outer shell and insulation in order to replace the sterilized squib switch with unsterilized switches from the same lot.

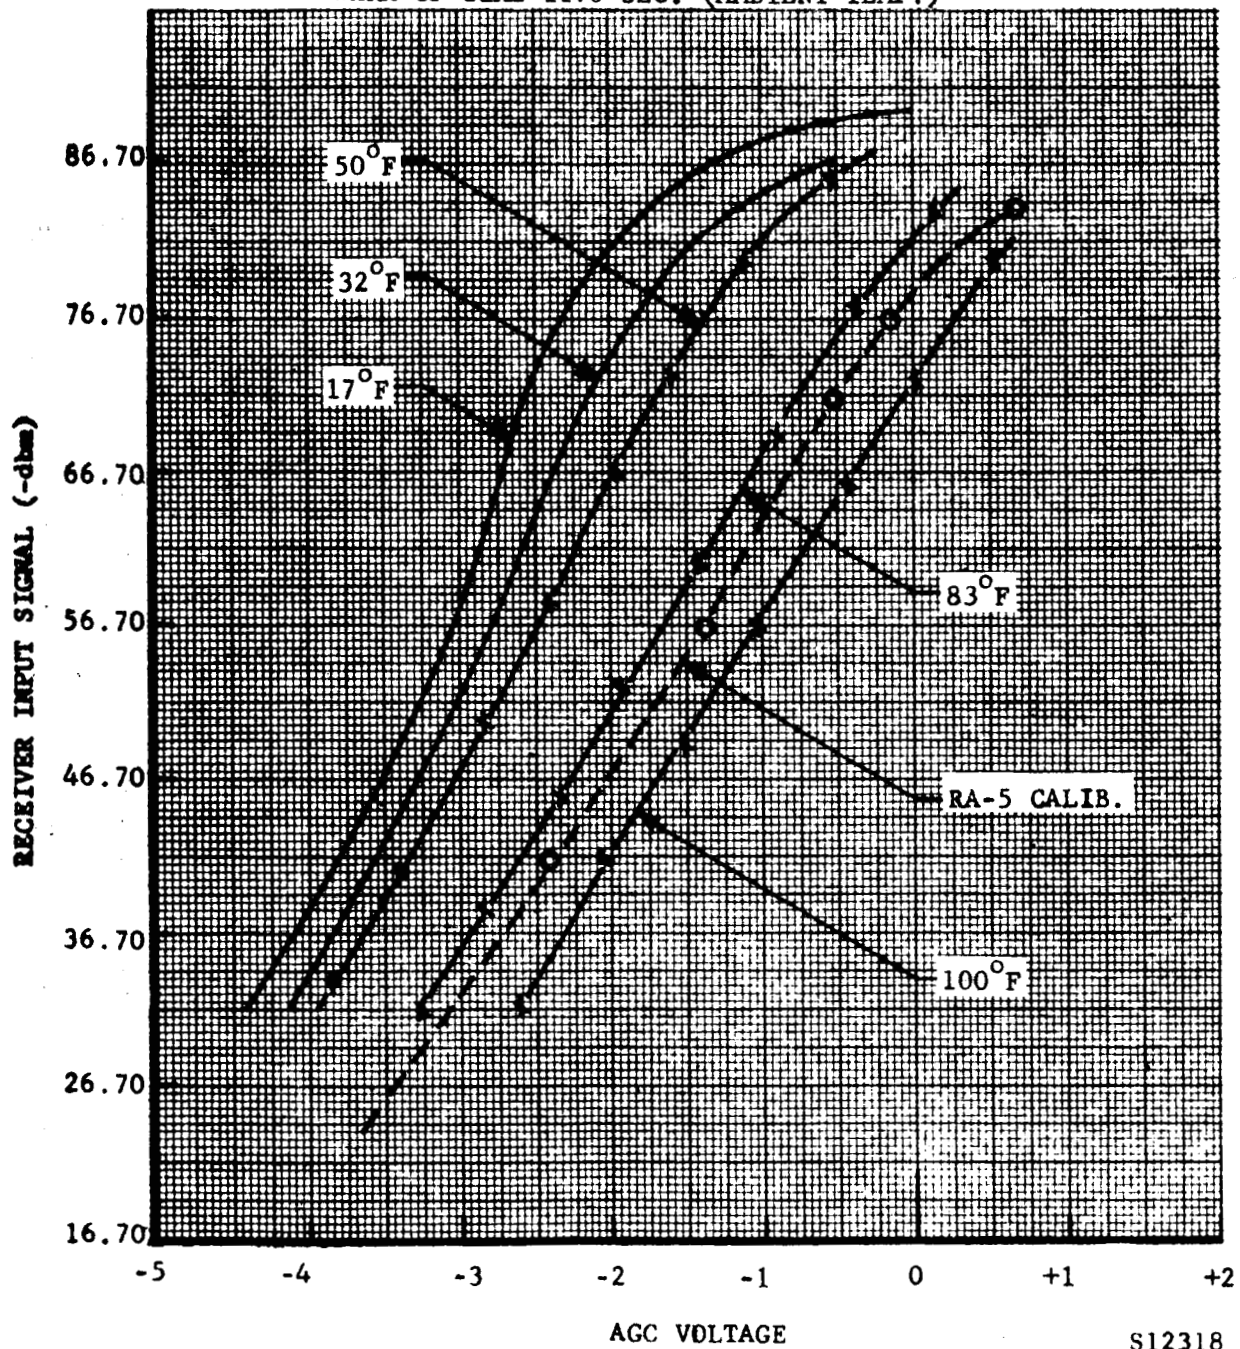
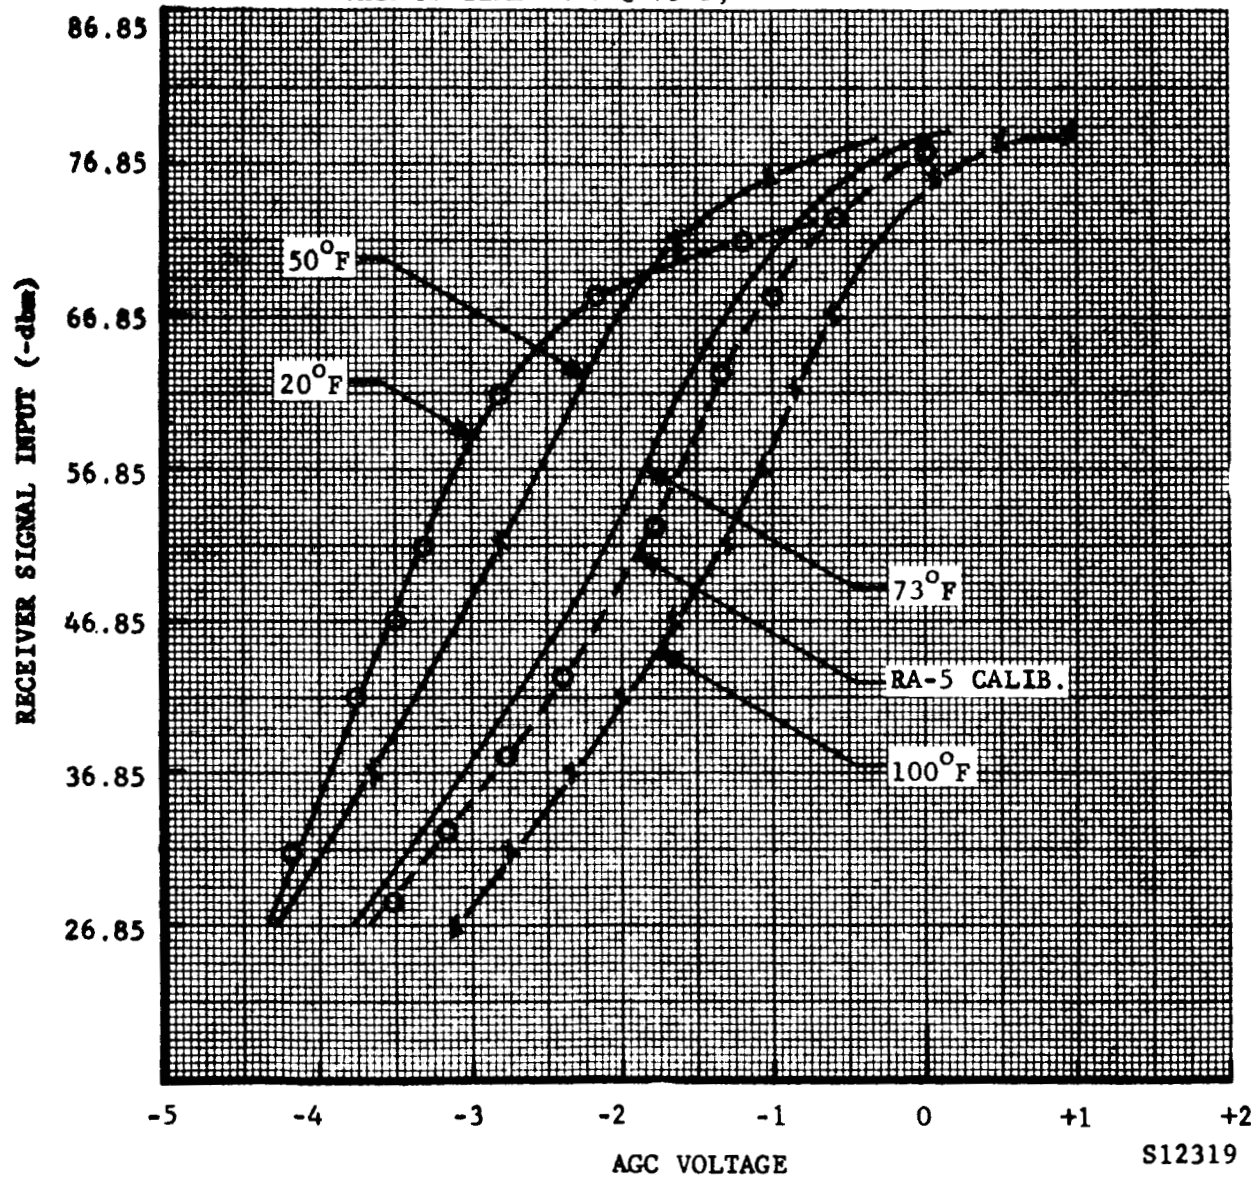
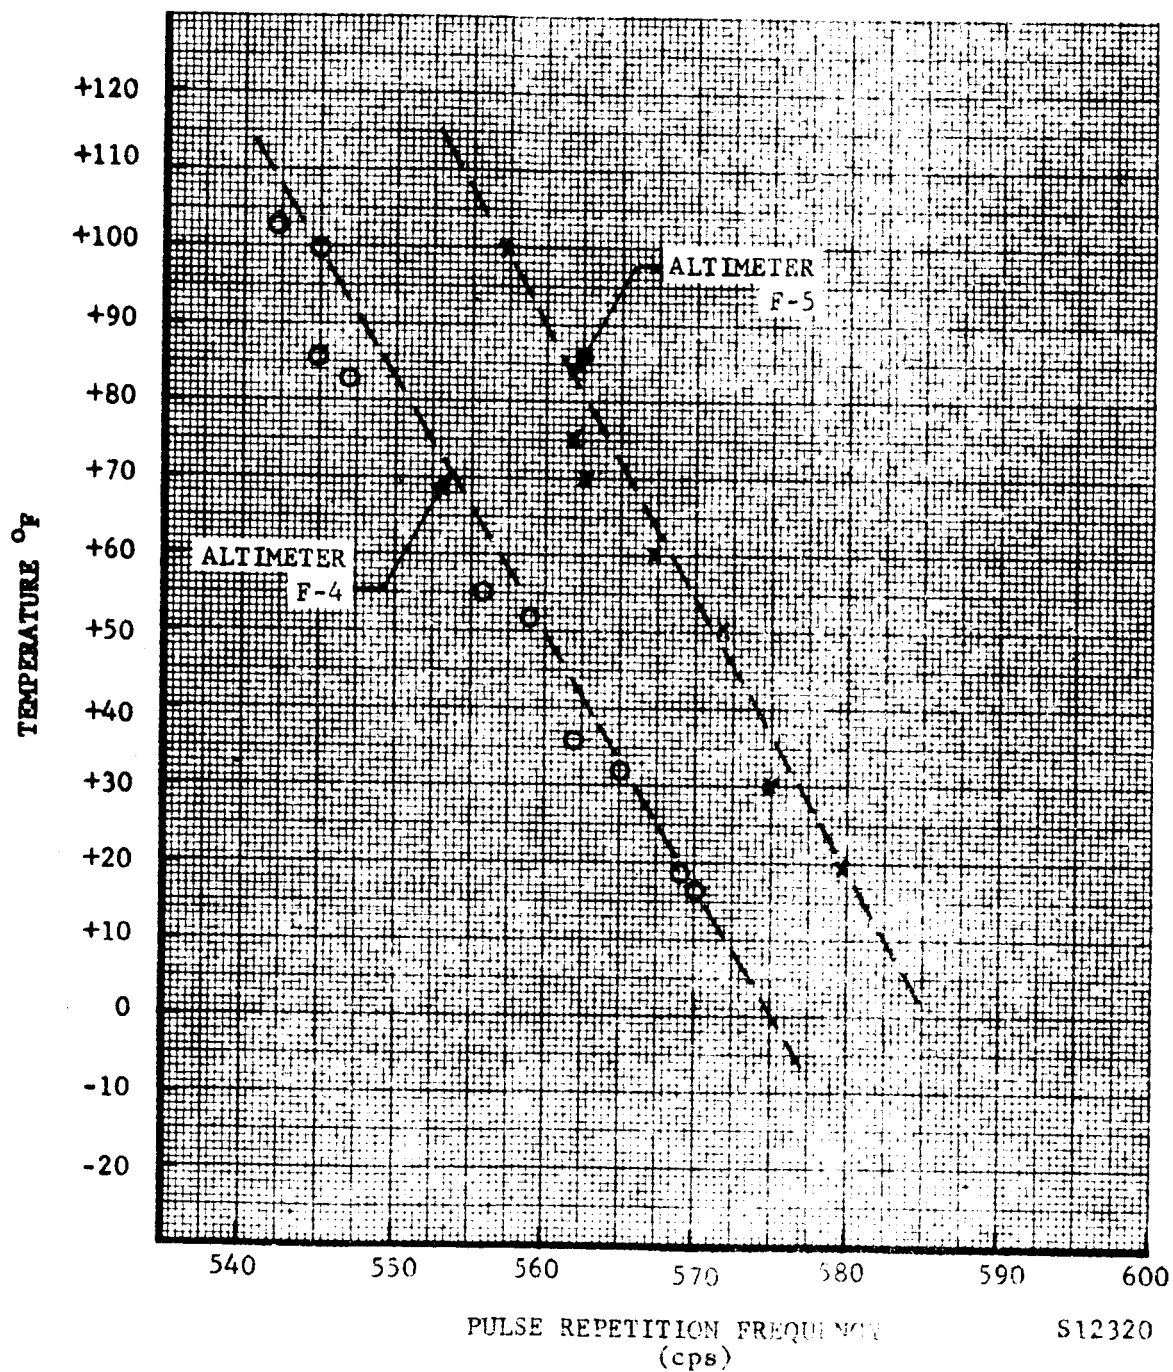
The curves of the AGC voltage versus altimeter temperature for altimeters F4 and F5 are shown in Figures 5, 6, and 7. The temperature characteristics of altimeter F4, the prime altimeter for RA-5, are normal in all respects. Some difficulties were experienced in obtaining satisfactory AGC voltage-temperature characteristics for altimeter F5. Whereas the AGC voltage itself was normal, the output of the preconditioning circuit for telemetry coding was significantly distorted. In particular, in the lower temperature ranges the AGC voltage tended to converge, so that meaningful data could not be obtained.

Since the AGC voltage conditioning circuit is integrally potted with the altimeter power supply, it was necessary to replace the power supply in altimeter F5 with that from F3. The resulting AGC voltage versus temperature curves were satisfactory, and the altimeter was accepted as the flight backup unit.
